A study on the variation of displacement and
internal earth pressure in creeping landslies(
Dissertation_全文)

A study on the variation of displacement and
internal earth pressure in creeping landslides

Thesis submitted to Graduate School of Science
in partial fulfillment of the requirements of the degree
Doctor of Science
in the Division of Earth and Planetary Sciences
Graduate School of Science
Kyoto University

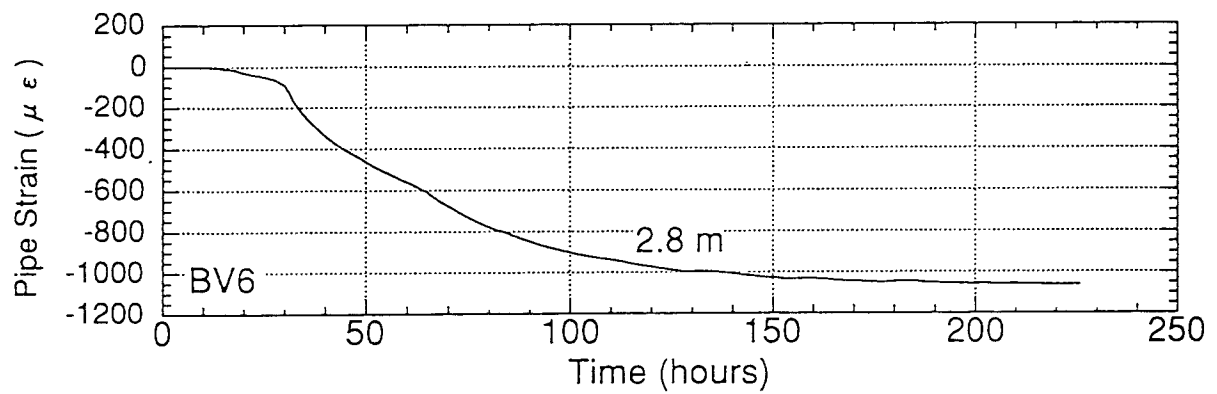
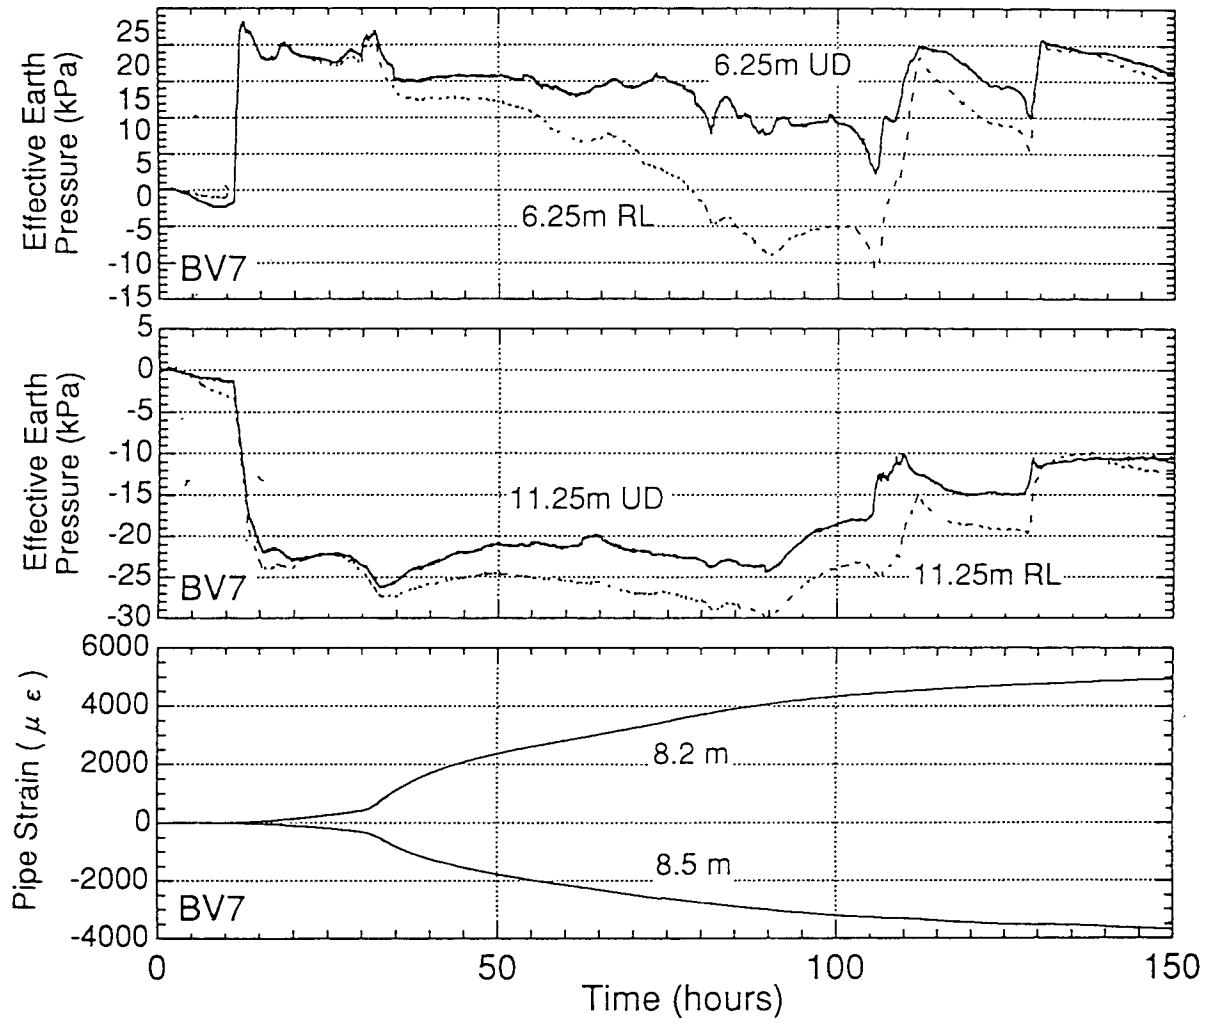
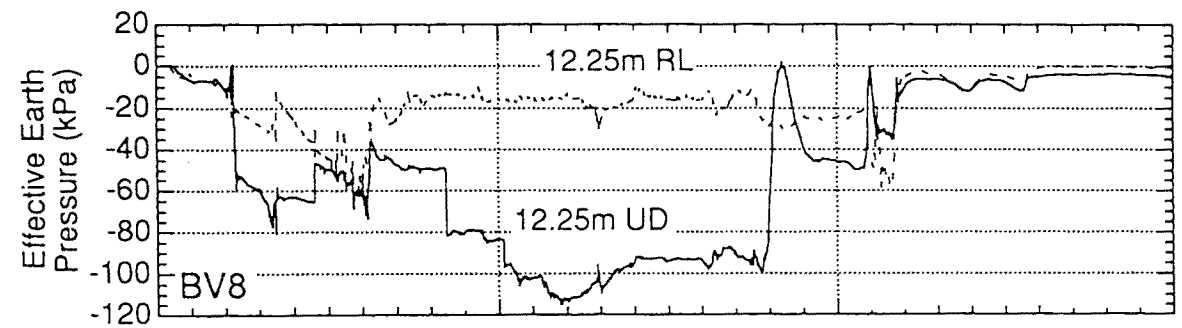
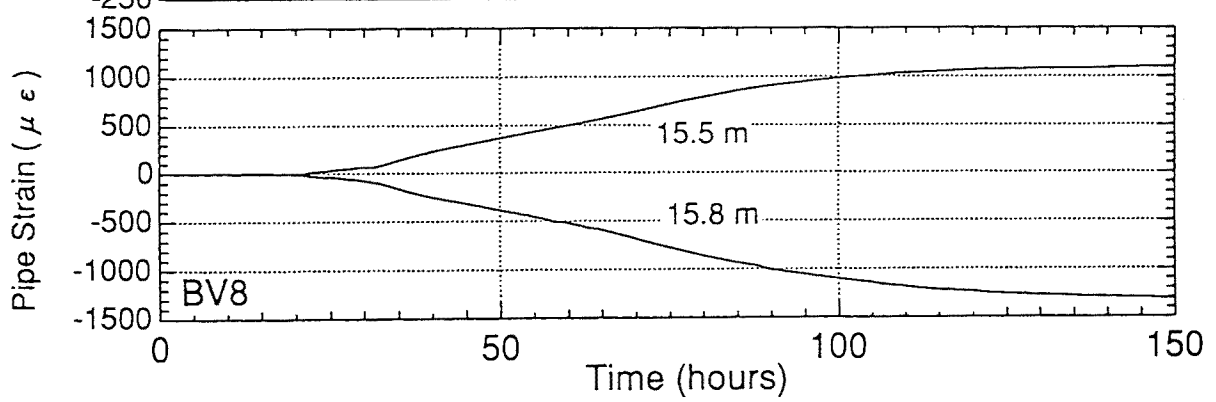
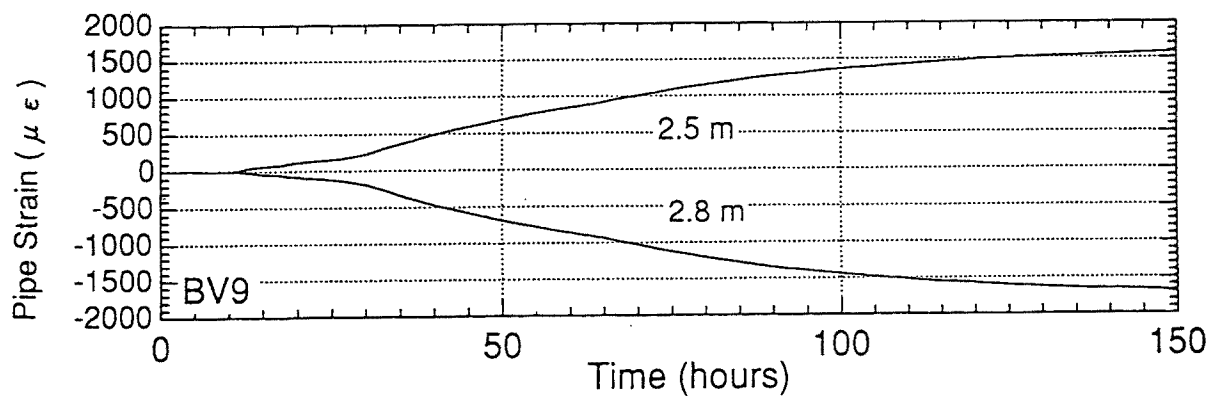
Appendix 2 (four pages): Calculated effective earth pressures for BV 5 to 9 in Event 1 and pipe strains at the slip surface (those for BV 4 are shown in Fig. 34).
